**SAS Superstructure**

Location: 04-SF-80-13.2 / 13.9

Daily Diary Report by Bid Item

Contract No.: 04-0120F4

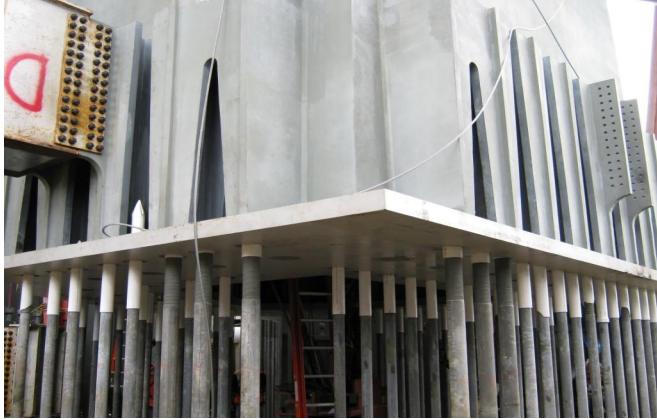
East shaft with all anchor rods through base plate holes

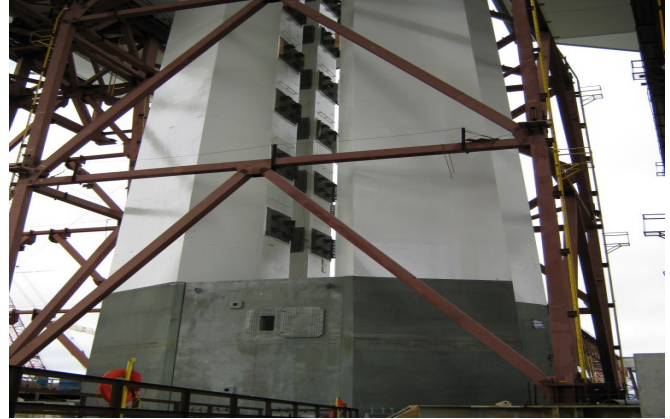
All Tower Lift 1 shaft in place
